Buyers Protection Group

4 Maple Street USA

Client(s): Smith
Inspection Date: 4/15/2015

Inspector: Timothy Clark #

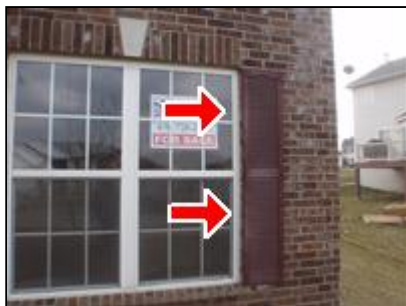
- Caulk and seal the gaps around the windows at the front of home. Seal where the brick meets the siding.

Example area, seal ALL gaped open areas around windows

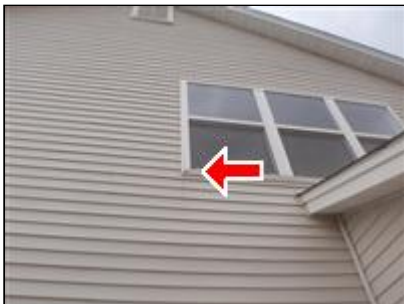
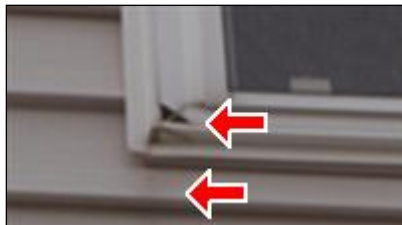
- At the east side of the home, at bottom corner of south master bedroom window, the bottom left corner of the window frame has a hole in it and there is a water streak on the siding below the hole. The hole appears to be a broken corner of the frame. Seal the area to ensure water can not enter into the wall. The current conditions in the wall are unknown.

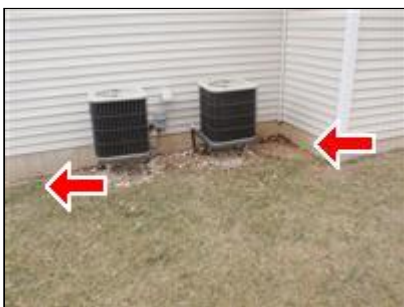
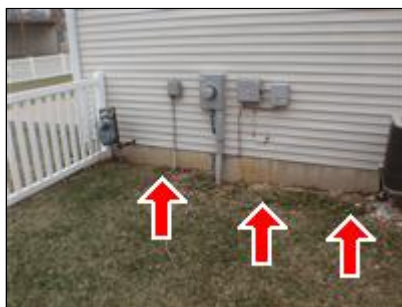
- ☒ ◆ The ground is low at area by the AC compressors and electric meter. Add dirt to area to slope the area away from the home. The ground is also low at areas around the rear patio, add dirt to the areas to slope away. Monitor other areas around the home and ensure there is a positive slope away

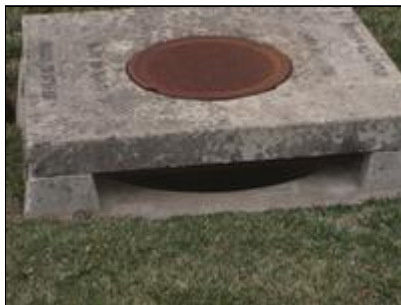
- ♦ Landscaping features are in generally good repair and the grounds tended typically for the area.
- ♦ The storm drain in the front yard has openings on the sides large enough for small children to fall through. Install protective grates or contact the Sewer District for correction.

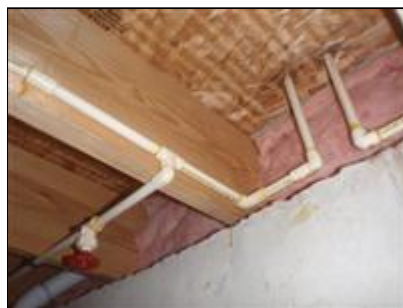
Example

- Every section of the water piping and all valves were not inspected. During the inspection the water was left running for about 40 minutes at each sink, tub and shower and all toilets were flushed at least three times.
- The plastic water supply pipe in service at this property is serviceable and meets national building codes but may not be accepted locally. This was not a code inspection.

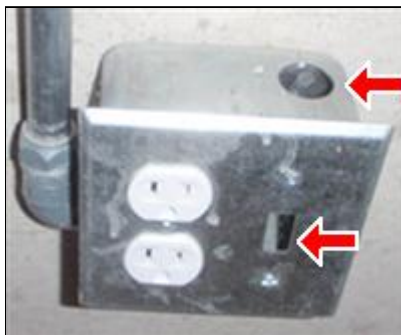
- ◆ This inspection included an operational check of randomly sampled accessible receptacles and switches, every light switch and outlet was not tested. Those that were checked were found acceptable unless otherwise noted in this report. Outlets behind heavy furniture or otherwise inaccessible were not checked. The two prong outlets were not tested.
- ☒ ◆ Install a different junction box or seal-up the open knockouts in the junction box mounted on west basement wall.
